# Flexible Circuit Failure Sleuthing

Start at the finish: the event that signaled the failure.

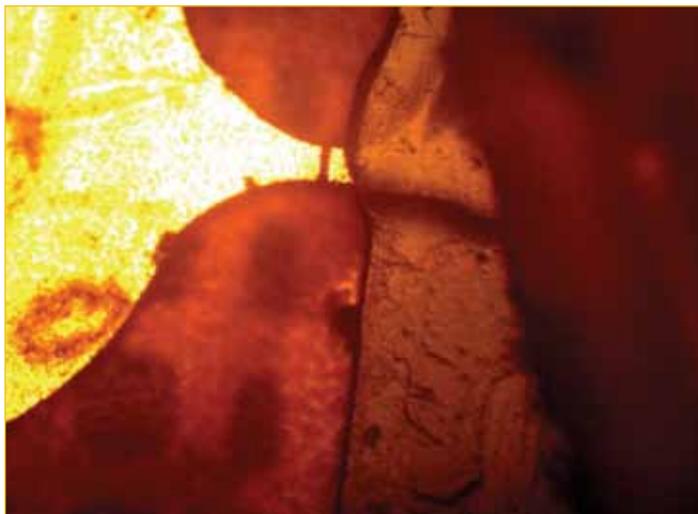
**FIGURE 3.** Conductor crack caused by stress concentration point.

tion and carefully inspect for cracks. Again, the cracks you seek will usually be very small and may appear to just be a line across the conductor. **FIGURE 3** illustrates an excellent example of what *not* to do in your design. Notice how the narrow conductor is exposed for a very short length. This conductor was also plated with nickel/gold, which is another no-no in an area that

may flex. Nickel plating is very brittle, and even a small amount of flexing can cause a crack, which will then propagate through the entire conductor thickness.
